MEMORANDUM

RE: Site History: South Dayton Dump and Landfill, Moraine, Ohio (Site)

Site Background and Overview of Site History

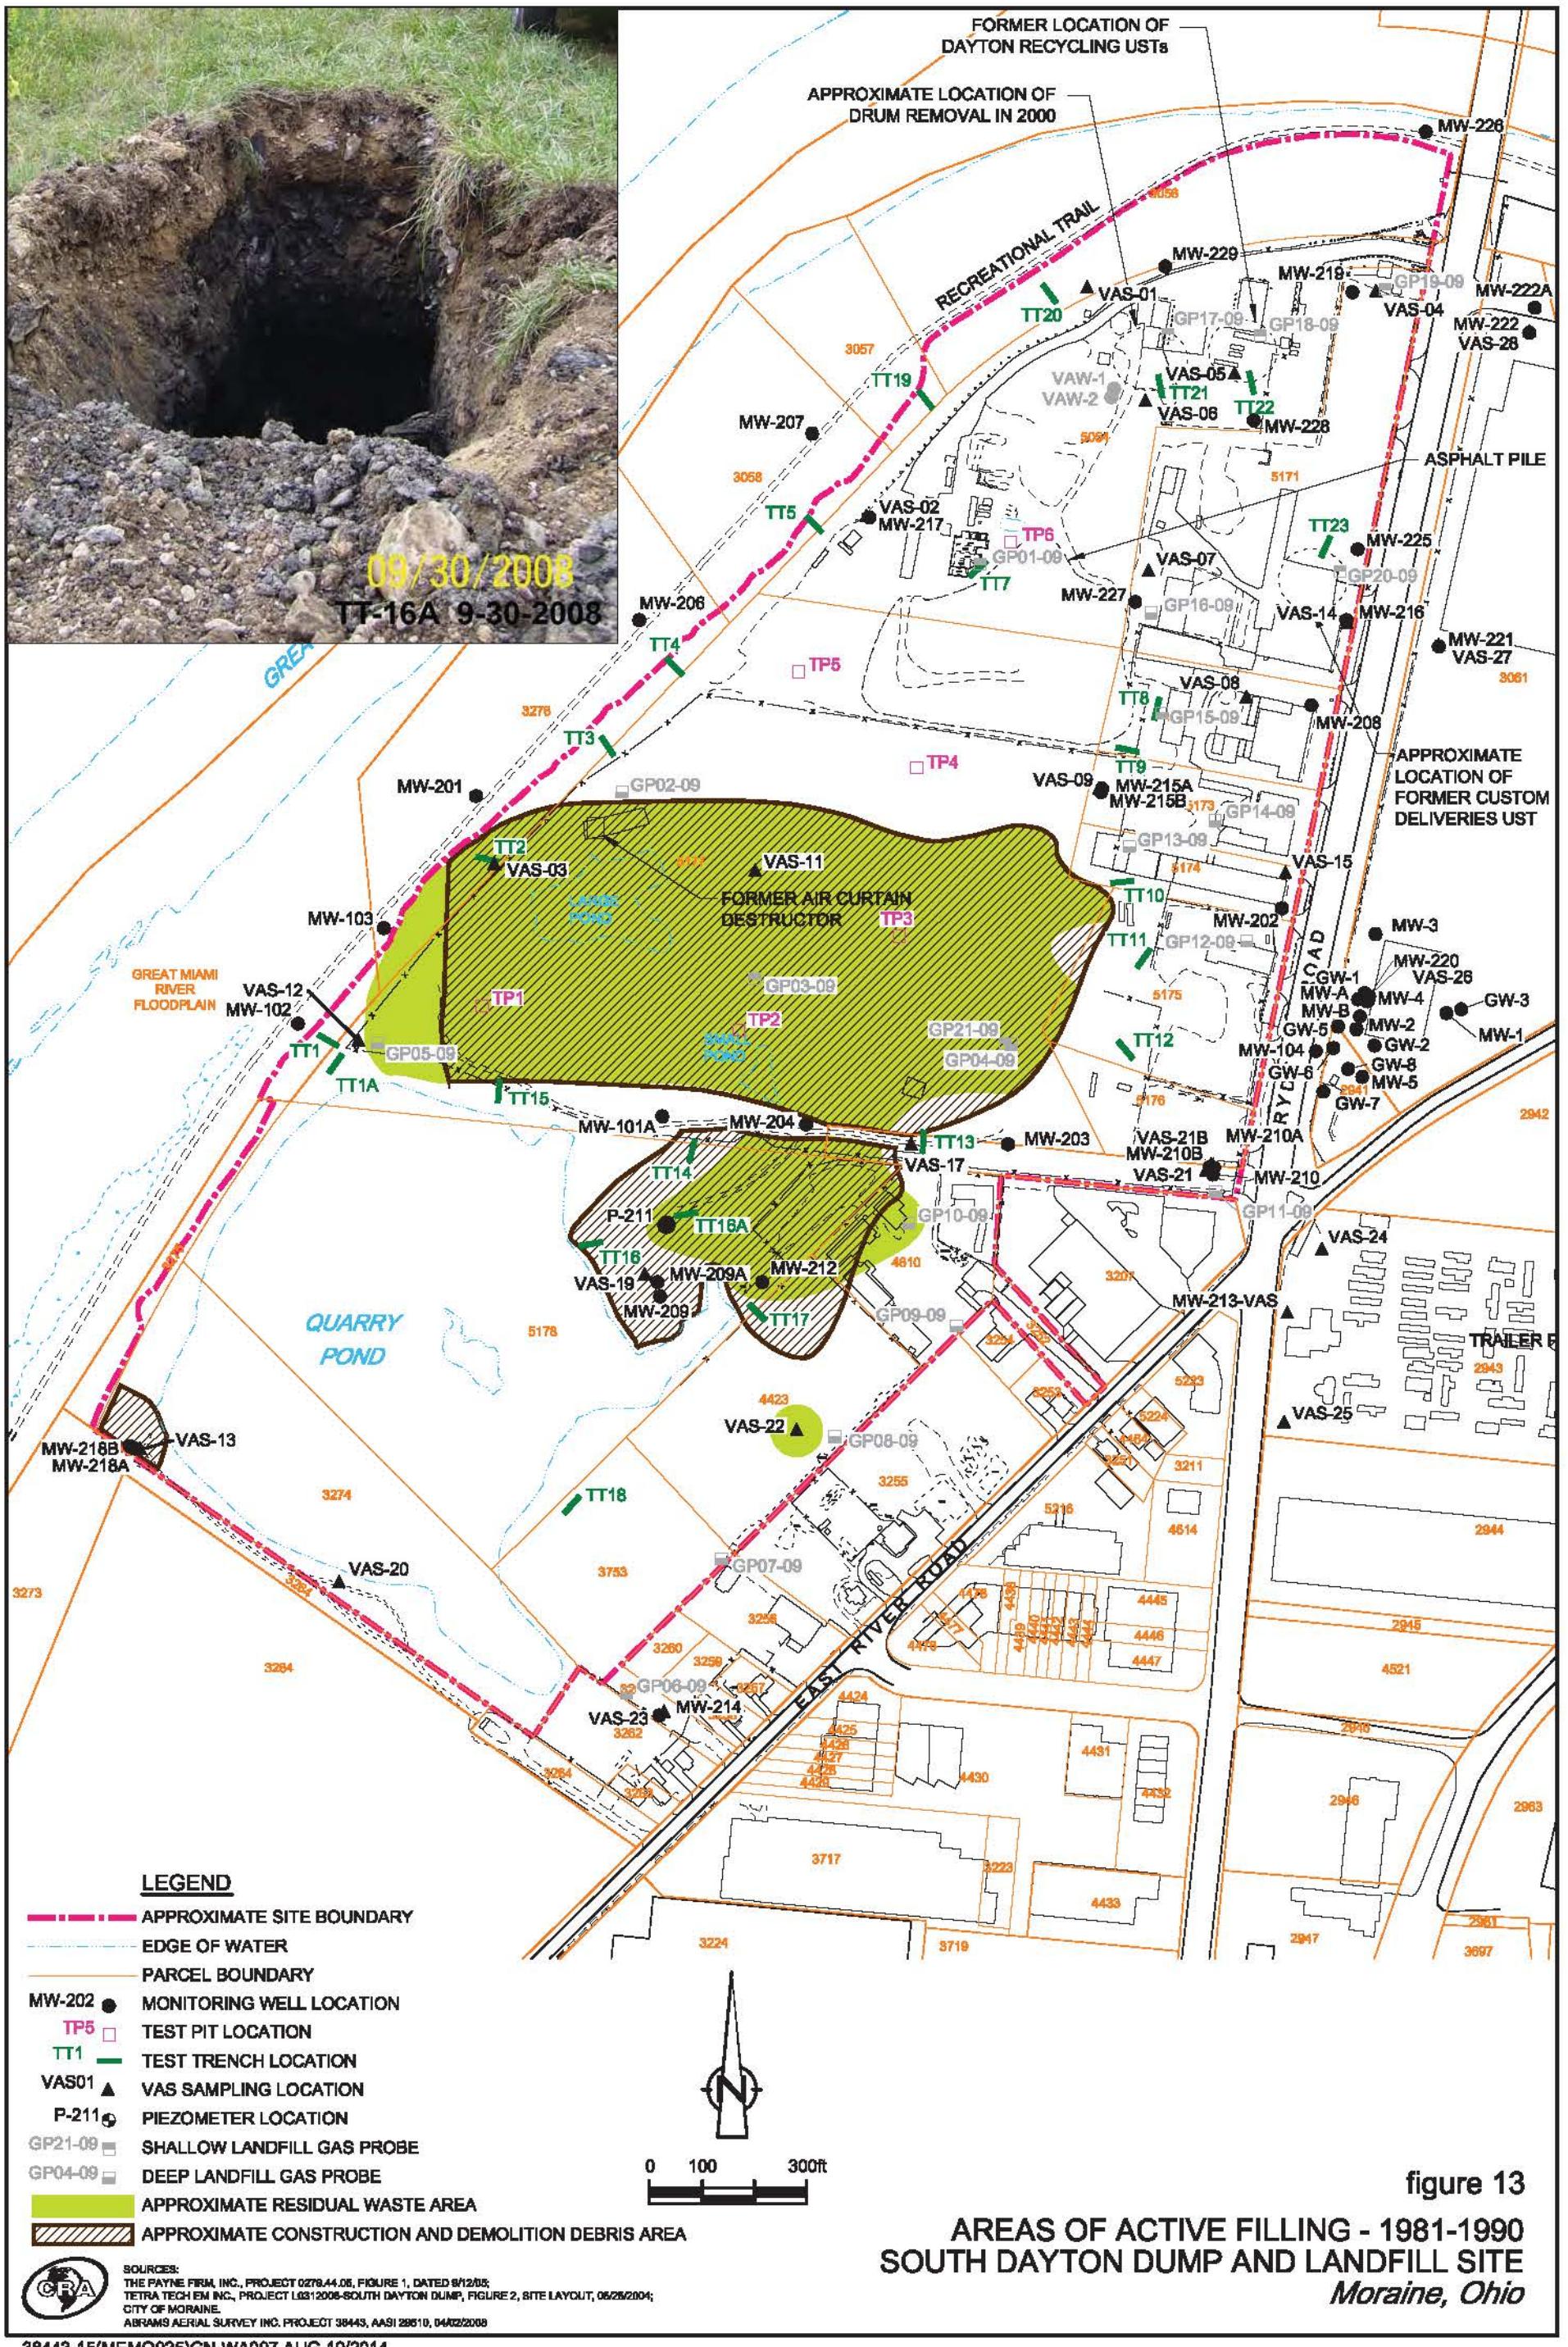
figure 13
AREAS OF ACTIVE FILLING - 1981-1990
SOUTH DAYTON DUMP AND LANDFILL SITE
Moraine, Ohio

- 1969-1975: Operation of an approximately 15 acre portion of the Site as a licensed solid waste landfill subject to the requirements of HE-24ⁱ and accepting non-putrescible industrial, residual, and household wastes as well as CDD (Figure 9).
- 1976-1980: Operation of an approximately 17 acre portion of the Site as a licensed solid waste landfill subject to the requirements of the 1976 version of Ohio Administrative Code (OAC) 3745-27 and limited to the following wastes: industrial, residual, and CDDⁱⁱ (Figure 11).
- 1981-1990: Operation of an approximately 20 acre portion of the Site as a licensed solid waste disposal facility which only received hard fill, residual waste, and CDD and was authorized pursuant to OAC 3745-27 (Figure 13).
- 1991-1996: The Site accepted only clean hard fill.

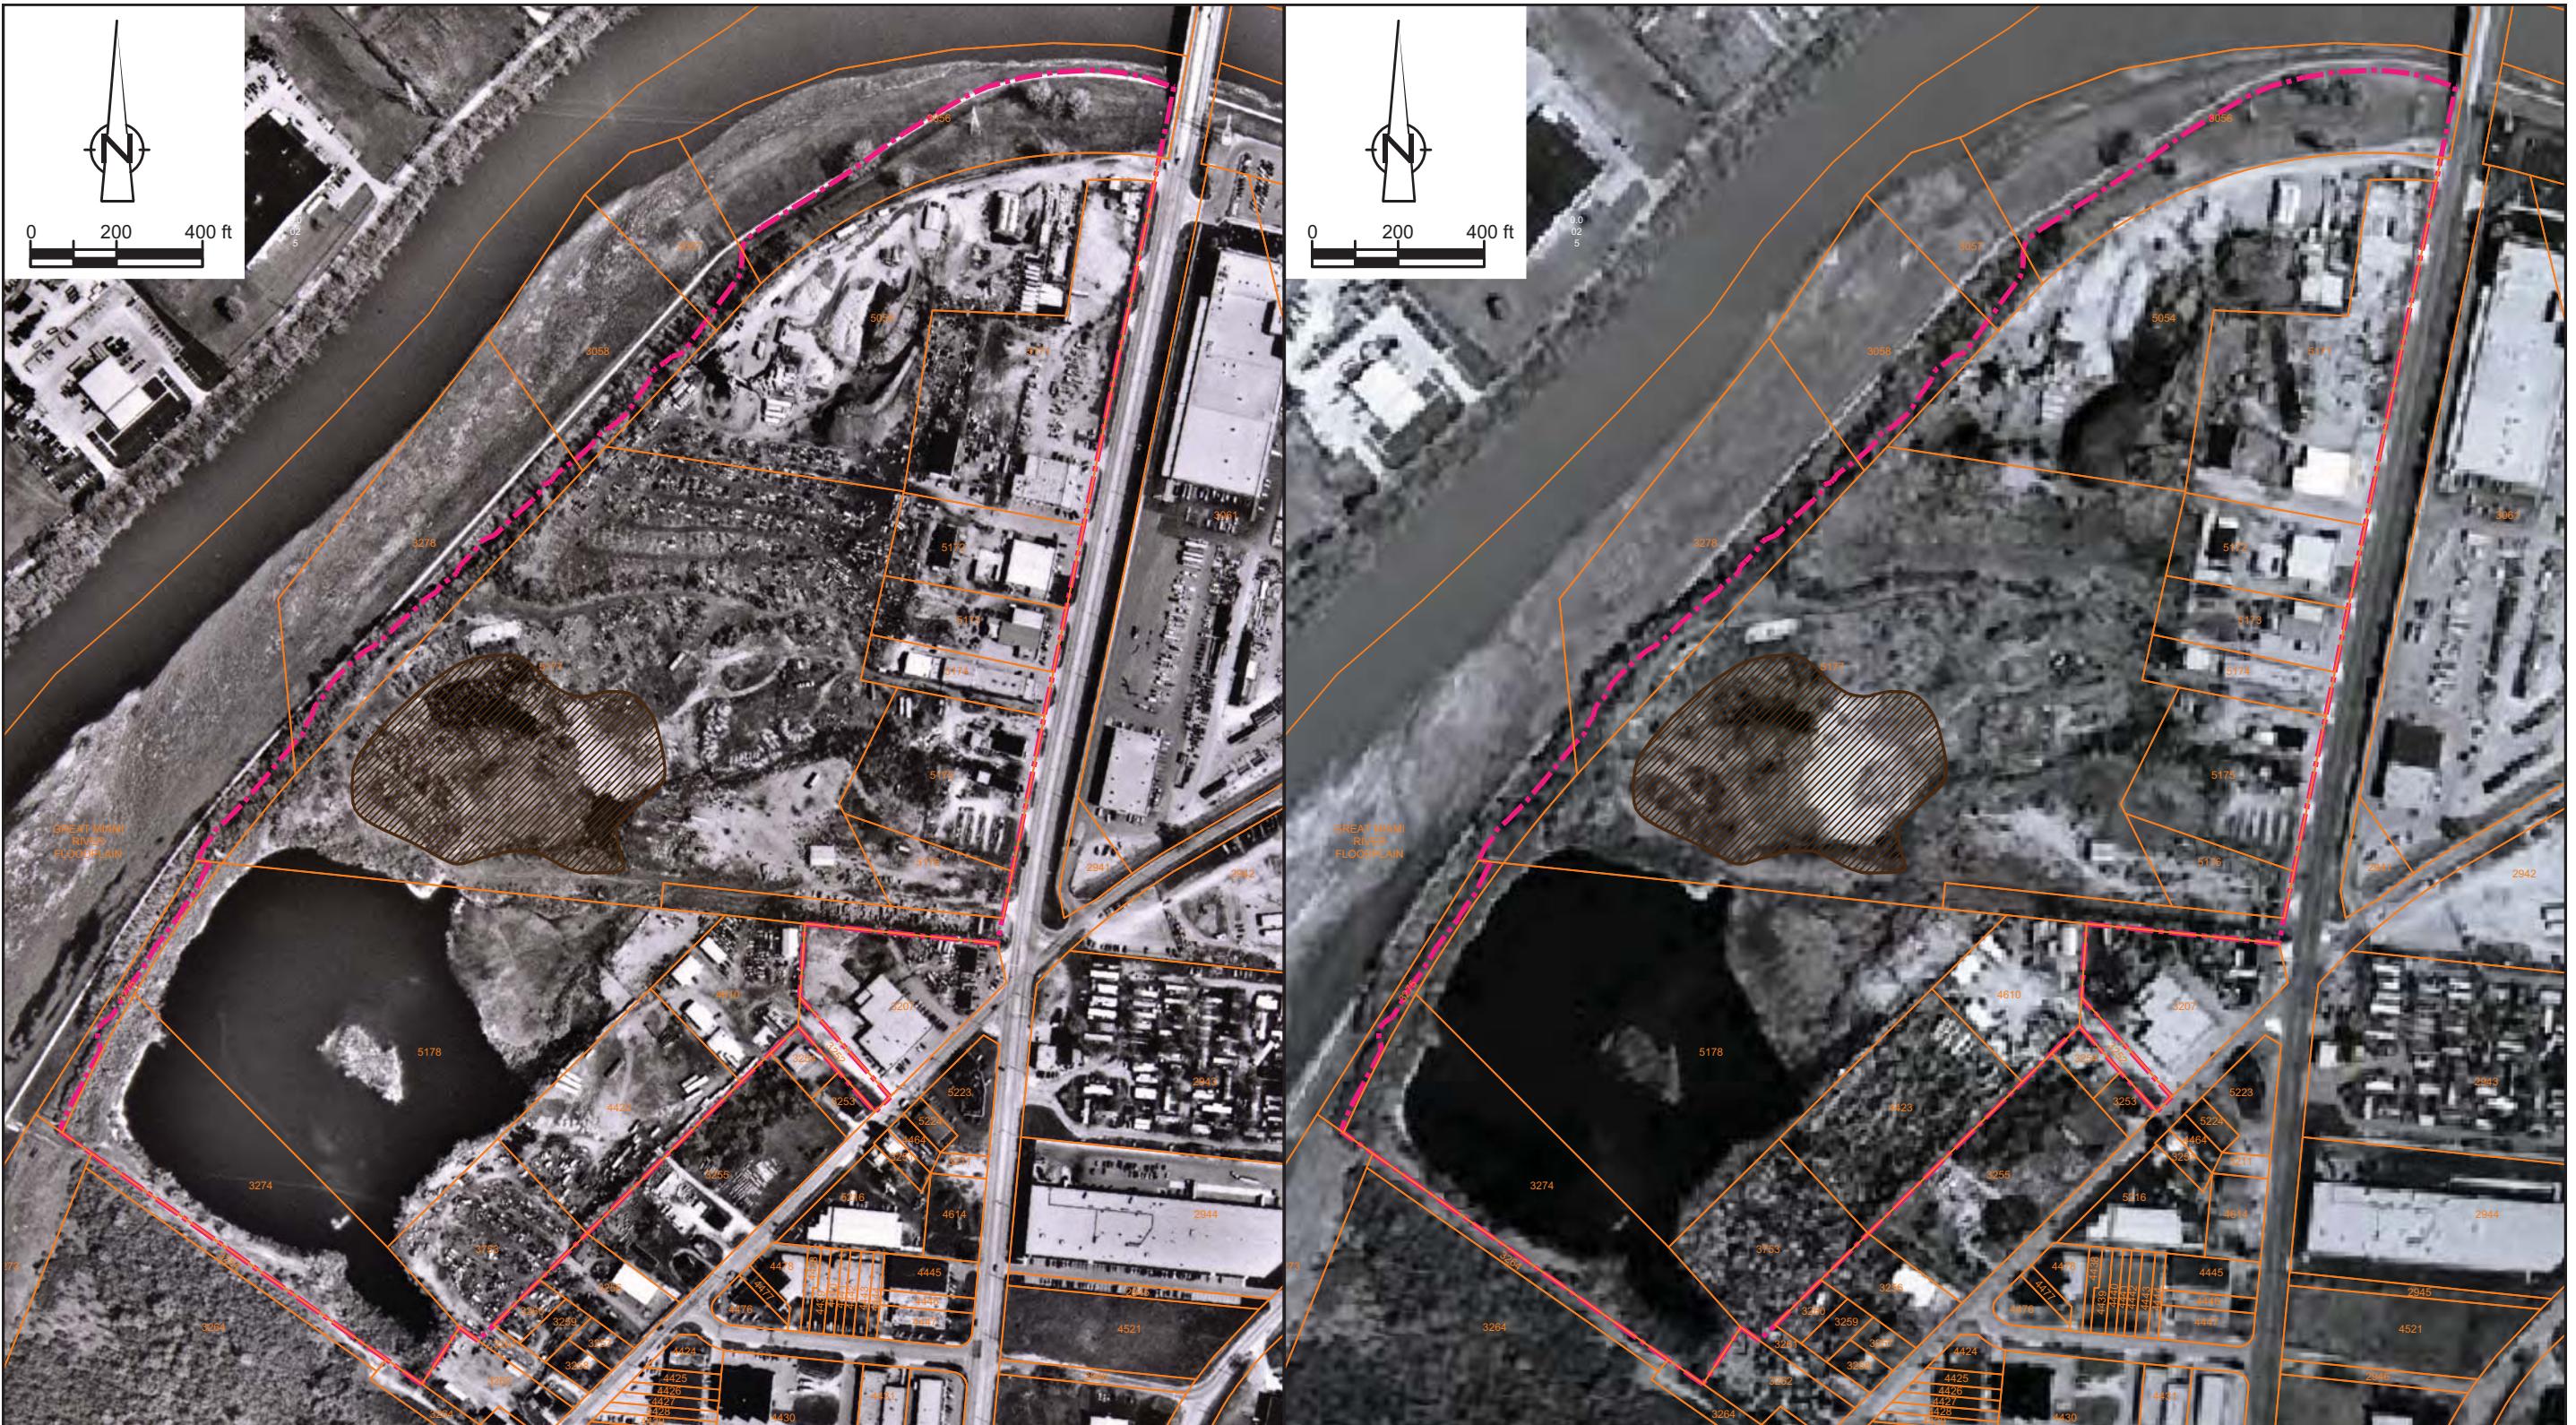
figure 14

AERIAL PHOTOS 1991-1996
SOUTH DAYTON DUMP AND LANDFILL SITE
Moraine, Ohio

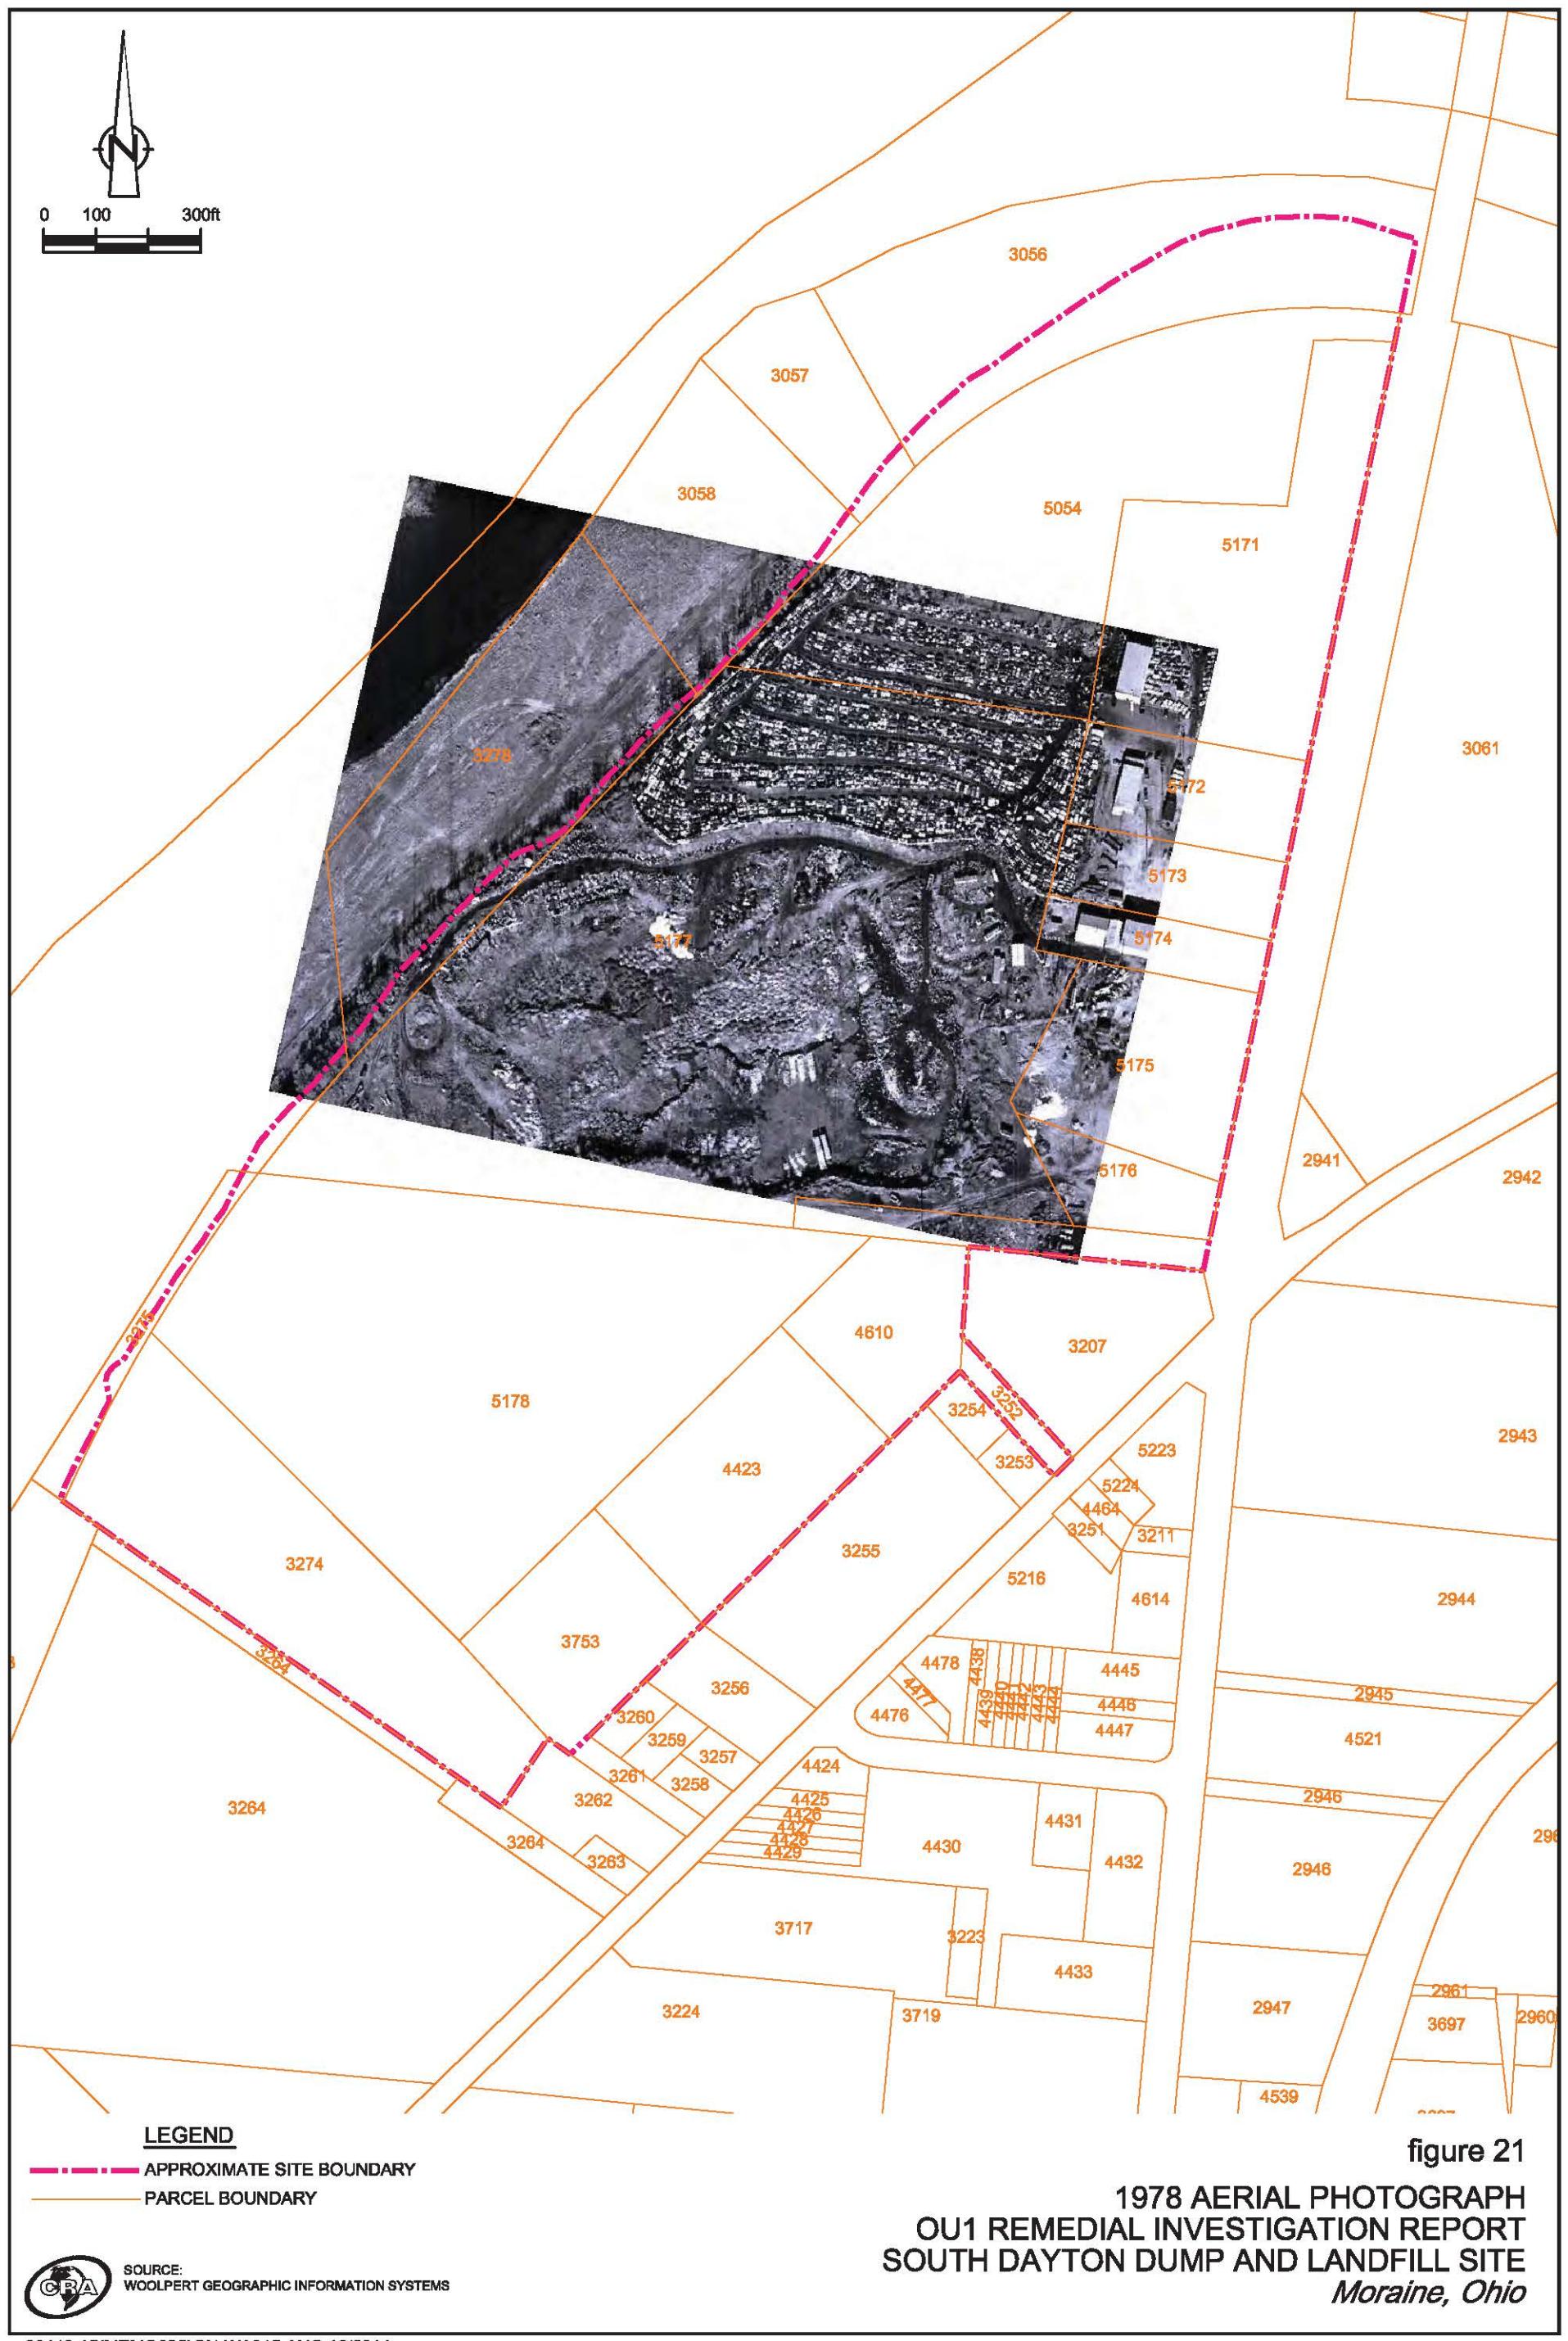
figure 21

**1978 AERIAL PHOTOGRAPH
OU1 REMEDIAL INVESTIGATION REPORT
SOUTH DAYTON DUMP AND LANDFILL SITE
*Moraine, Ohio***

The 1978 aerial photo (Figure 21) only shows the central portion of the Site but conditions were similar to the 1975 aerial photograph on Figure 10⁴.

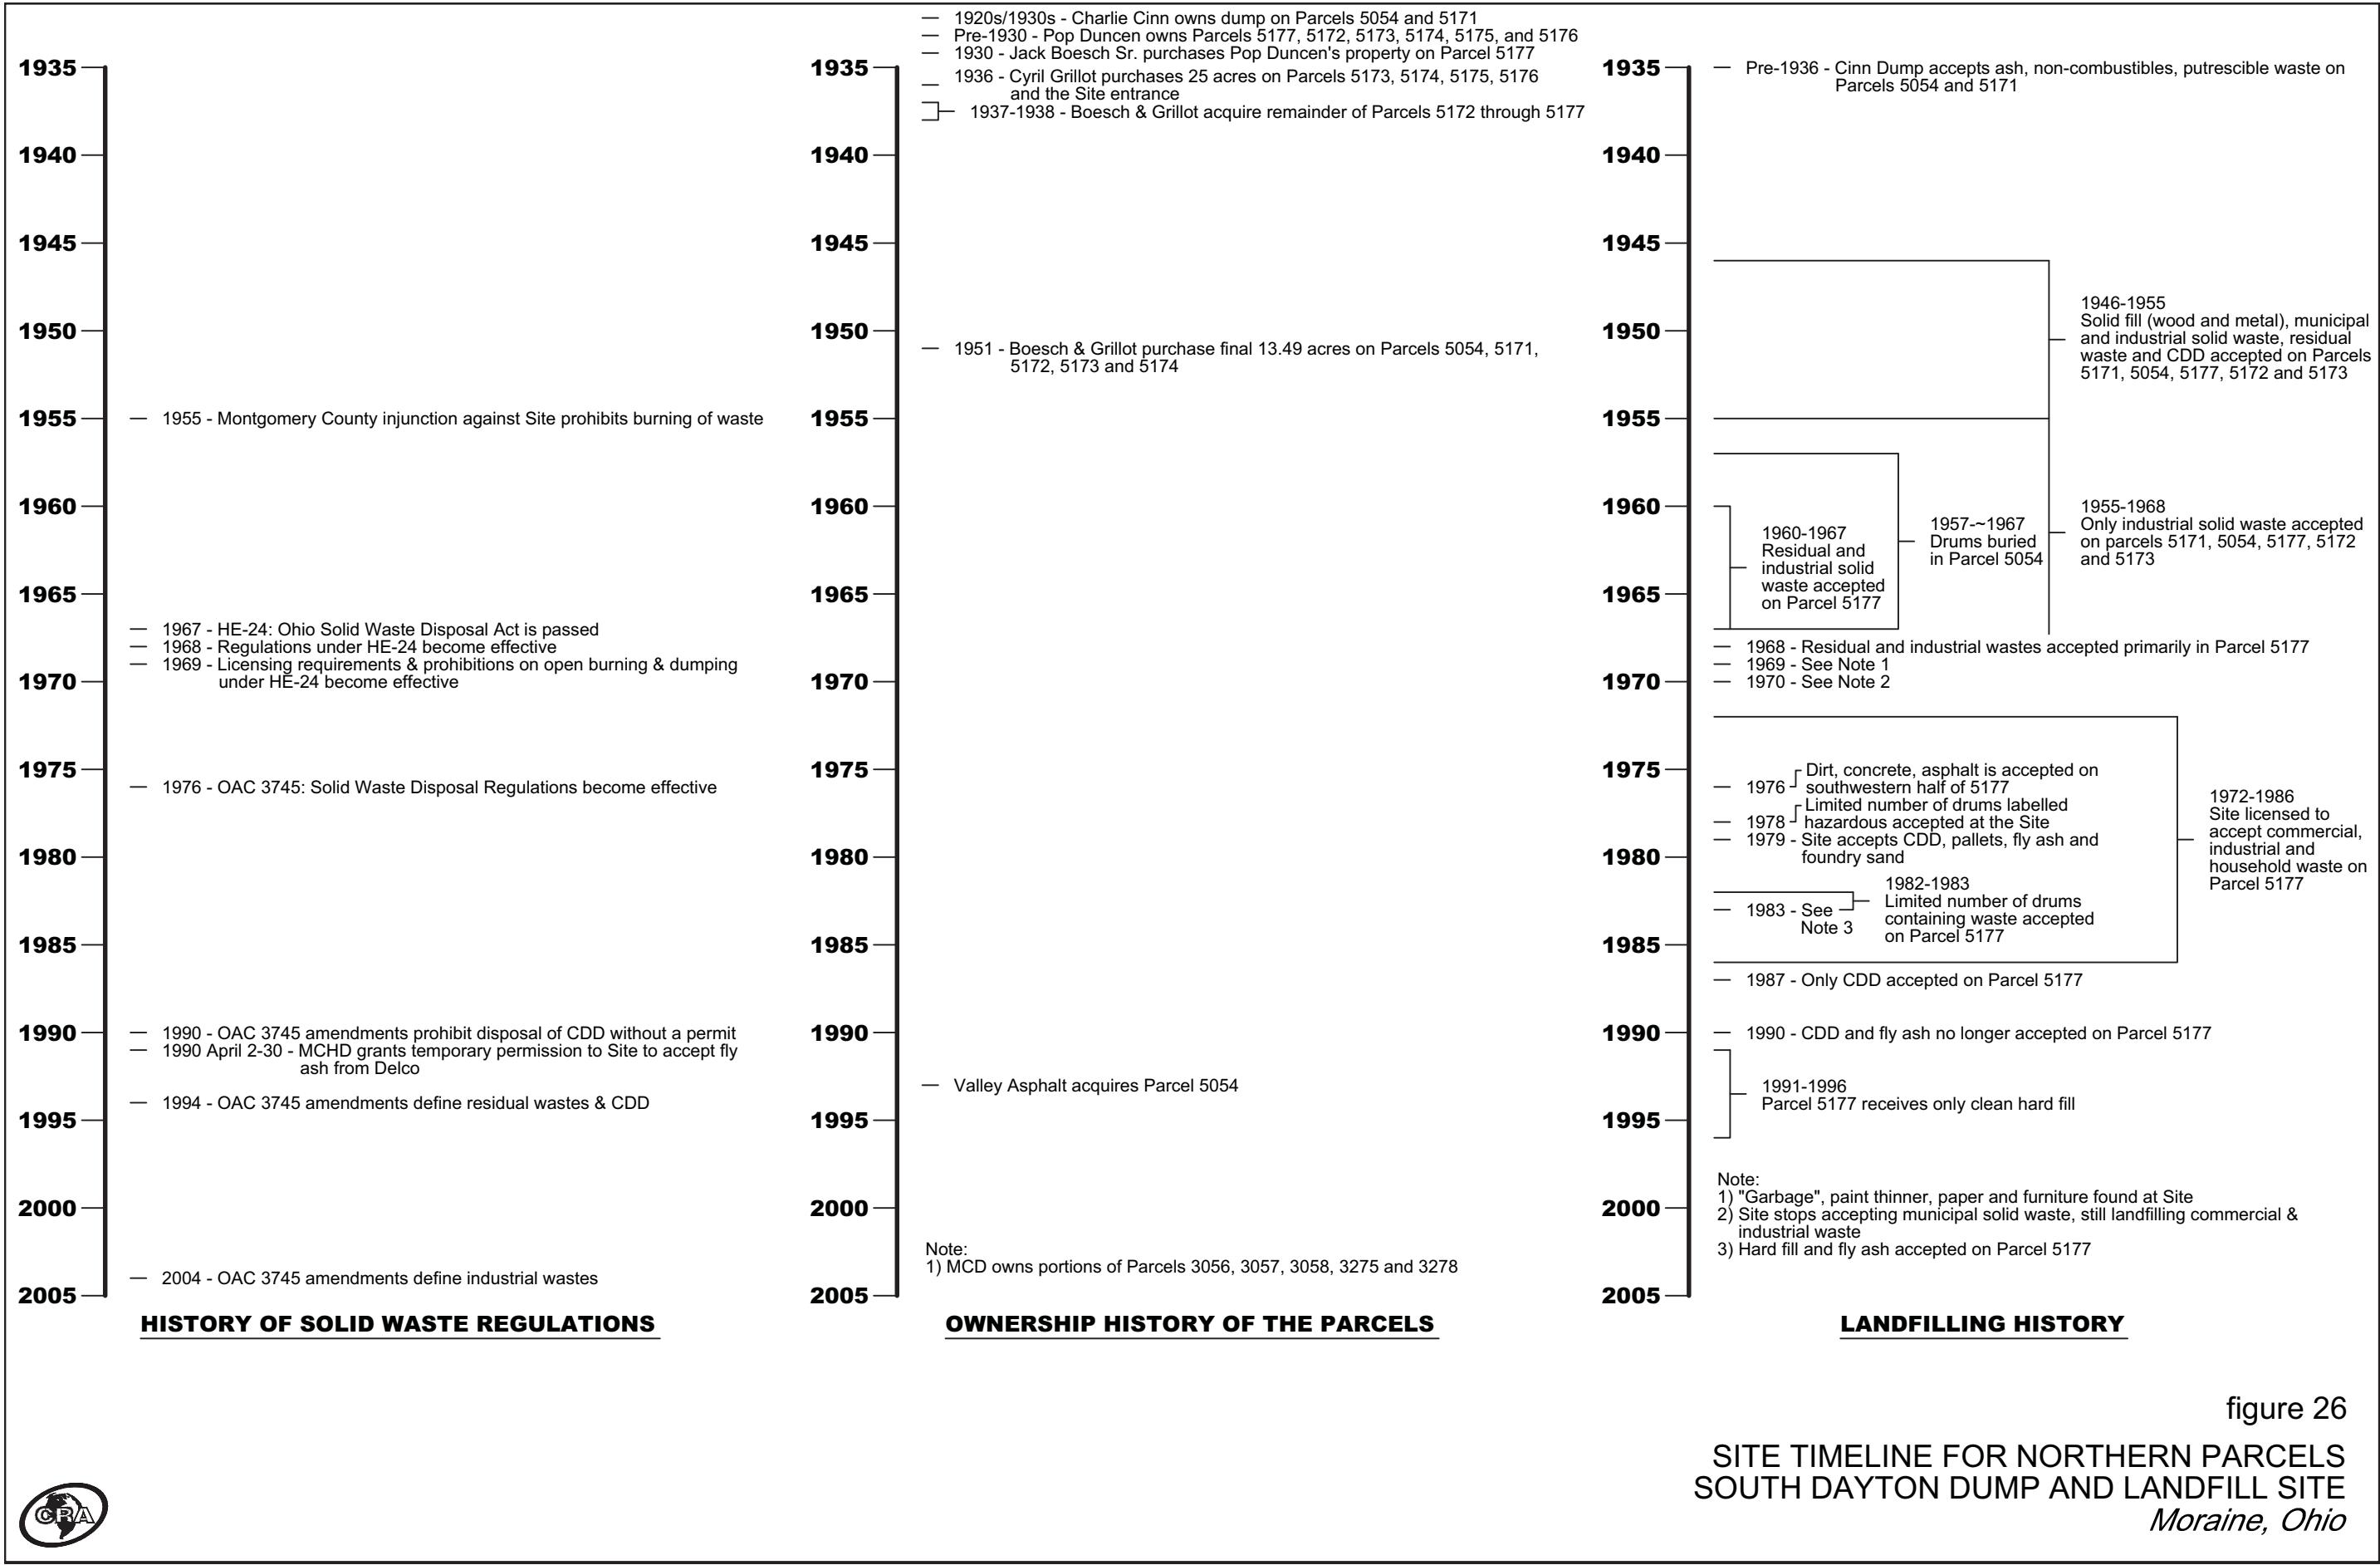
figure 26

SITE TIMELINE FOR NORTHERN PARCELS
SOUTH DAYTON DUMP AND LANDFILL SITE
Moraine, Ohio

A number of different commercial and industrial activities have historically operated and continue to operate at the Site as depicted on Figures 26 and 27.

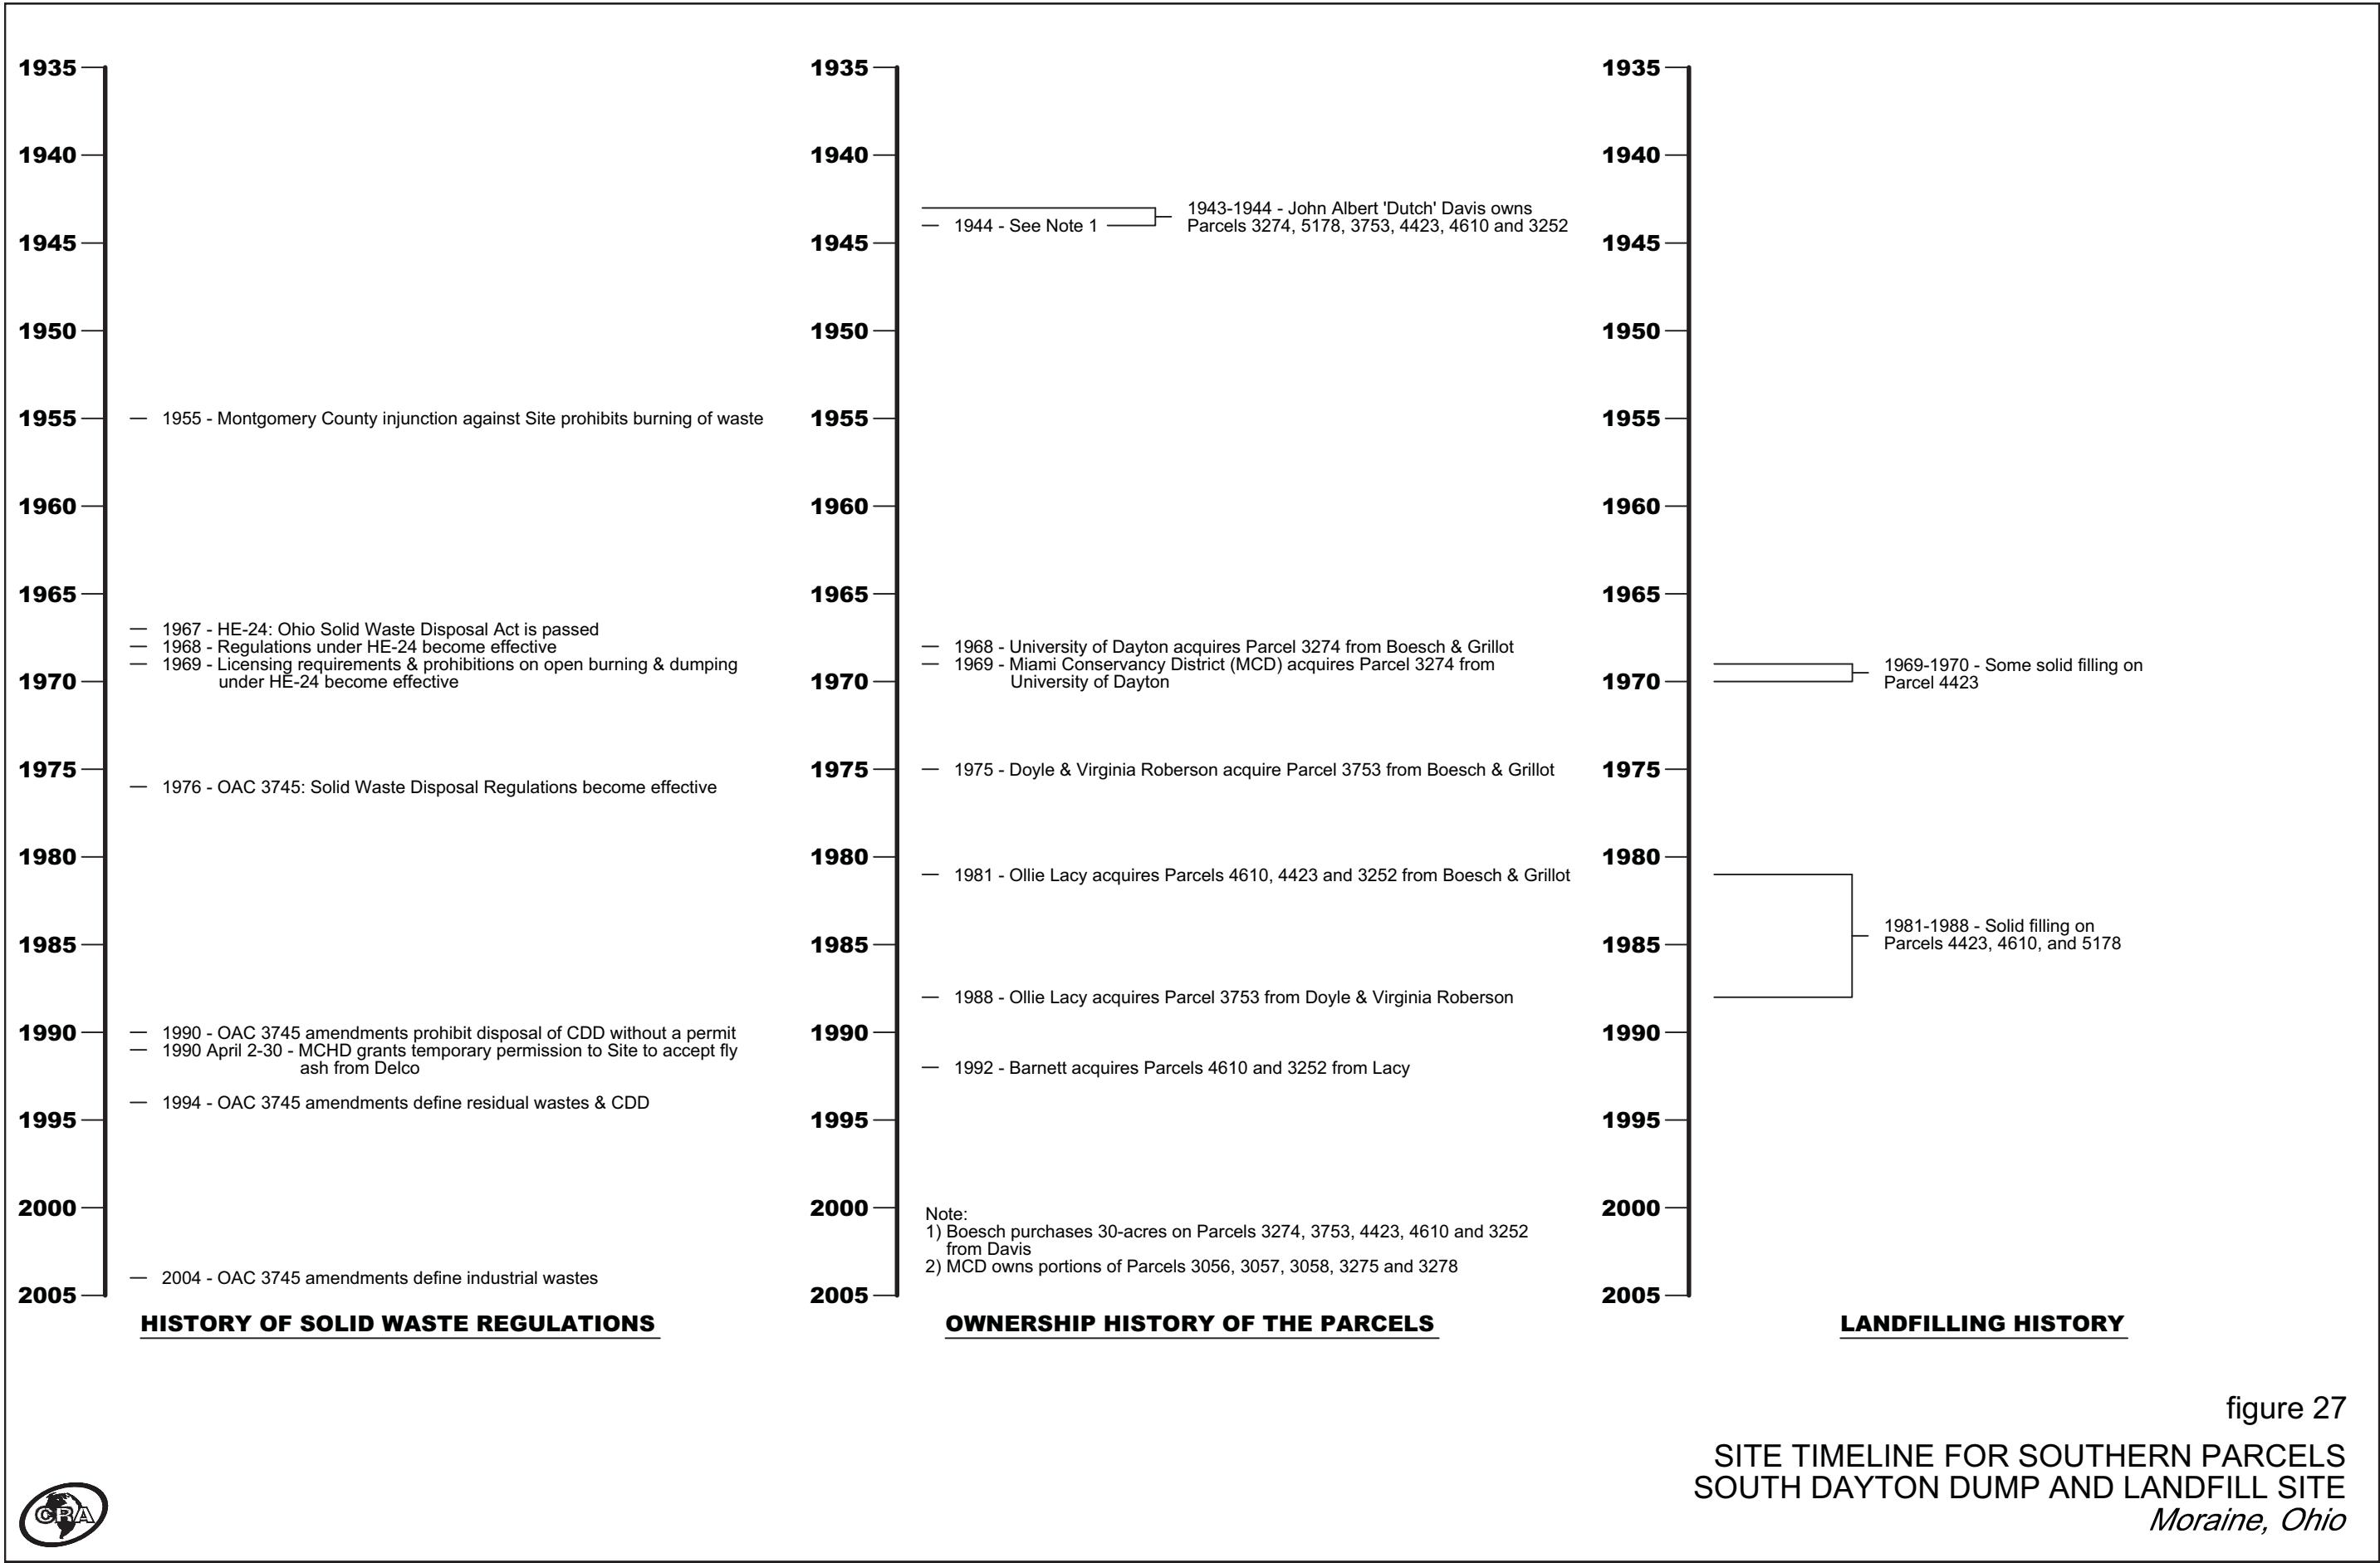
figure 27

SITE TIMELINE FOR SOUTHERN PARCELS
SOUTH DAYTON DUMP AND LANDFILL SITE
Moraine, Ohio
